SUPERALLOY KNIFE EDGE SEAL REPAIR

GENERAL ELECTRIC COMPANY
CINCINNATI, OHIO 45215

MAY 1978

TECHNICAL REPORT AFML-TR-78-56
Final Report for period 1 March 1976 to 31 November 1977

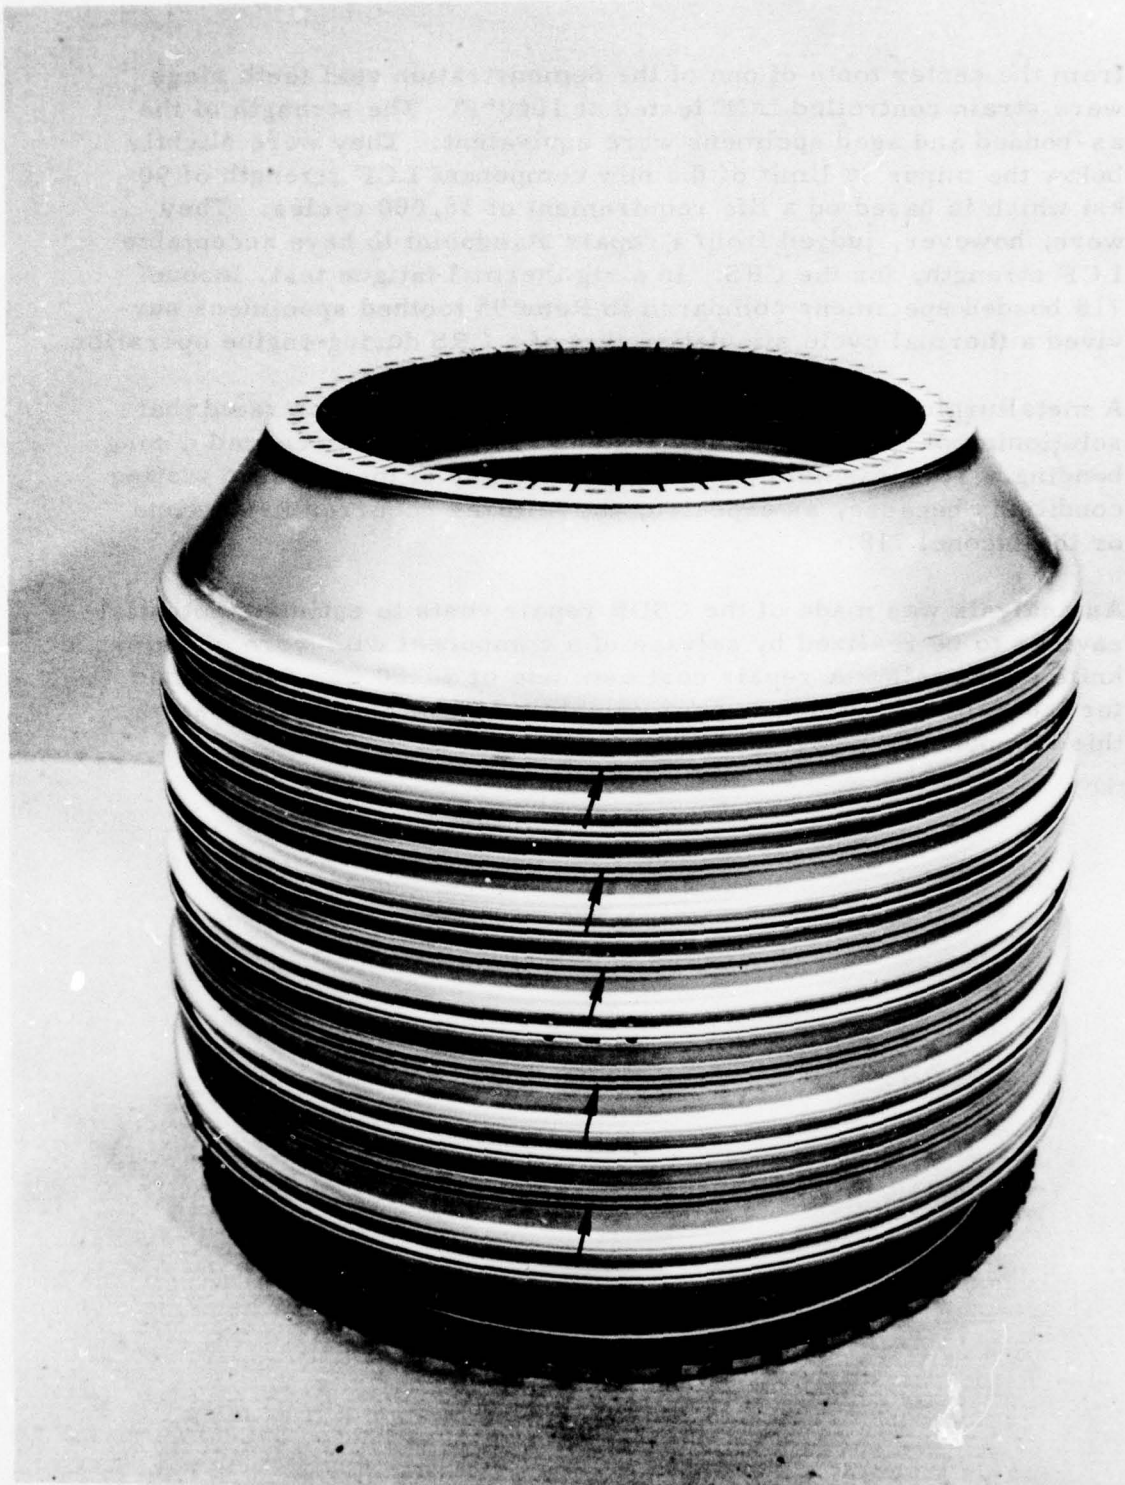
Figure 2. F101 René 95 Compressor Rotor Spool Stages 4 Through 9.

The F101, Rene'95, compressor rotor spool (CRS), Stages 4-9 was chosen because of the high payoff for a successful repair process. The multiple seal teeth in this design could result in scrapping an expensive part for tooth wear on a single tooth. It was also selected for other reasons: (1) it contained a typical seal tooth configuration, (2) the one to be used had seen engine operation and was representative of a component needing repair, (3) the seal material is Rene'95, a difficult material to join as it is very sensitive to cracking during welding - success with Rene'95 would predict applicability to virtually all superalloys - and, (4) there are numerous Rene'95 components on the F101 engine that contain seal teeth.

A F101, Rene'95, CRS, Stages 4-9 was obtained for the repair effort. At Solar, San Diego, California, five seal teeth rings containing three labyrinth seal teeth were machined from the areas designated by the arrows in previously shown Figure 2. The machining was accomplished by mounting the forward end of the CRS on the face plate of a lathe and progressively making circumferential cuts utilizing a tool post grinder with an abrasive cutoff wheel.

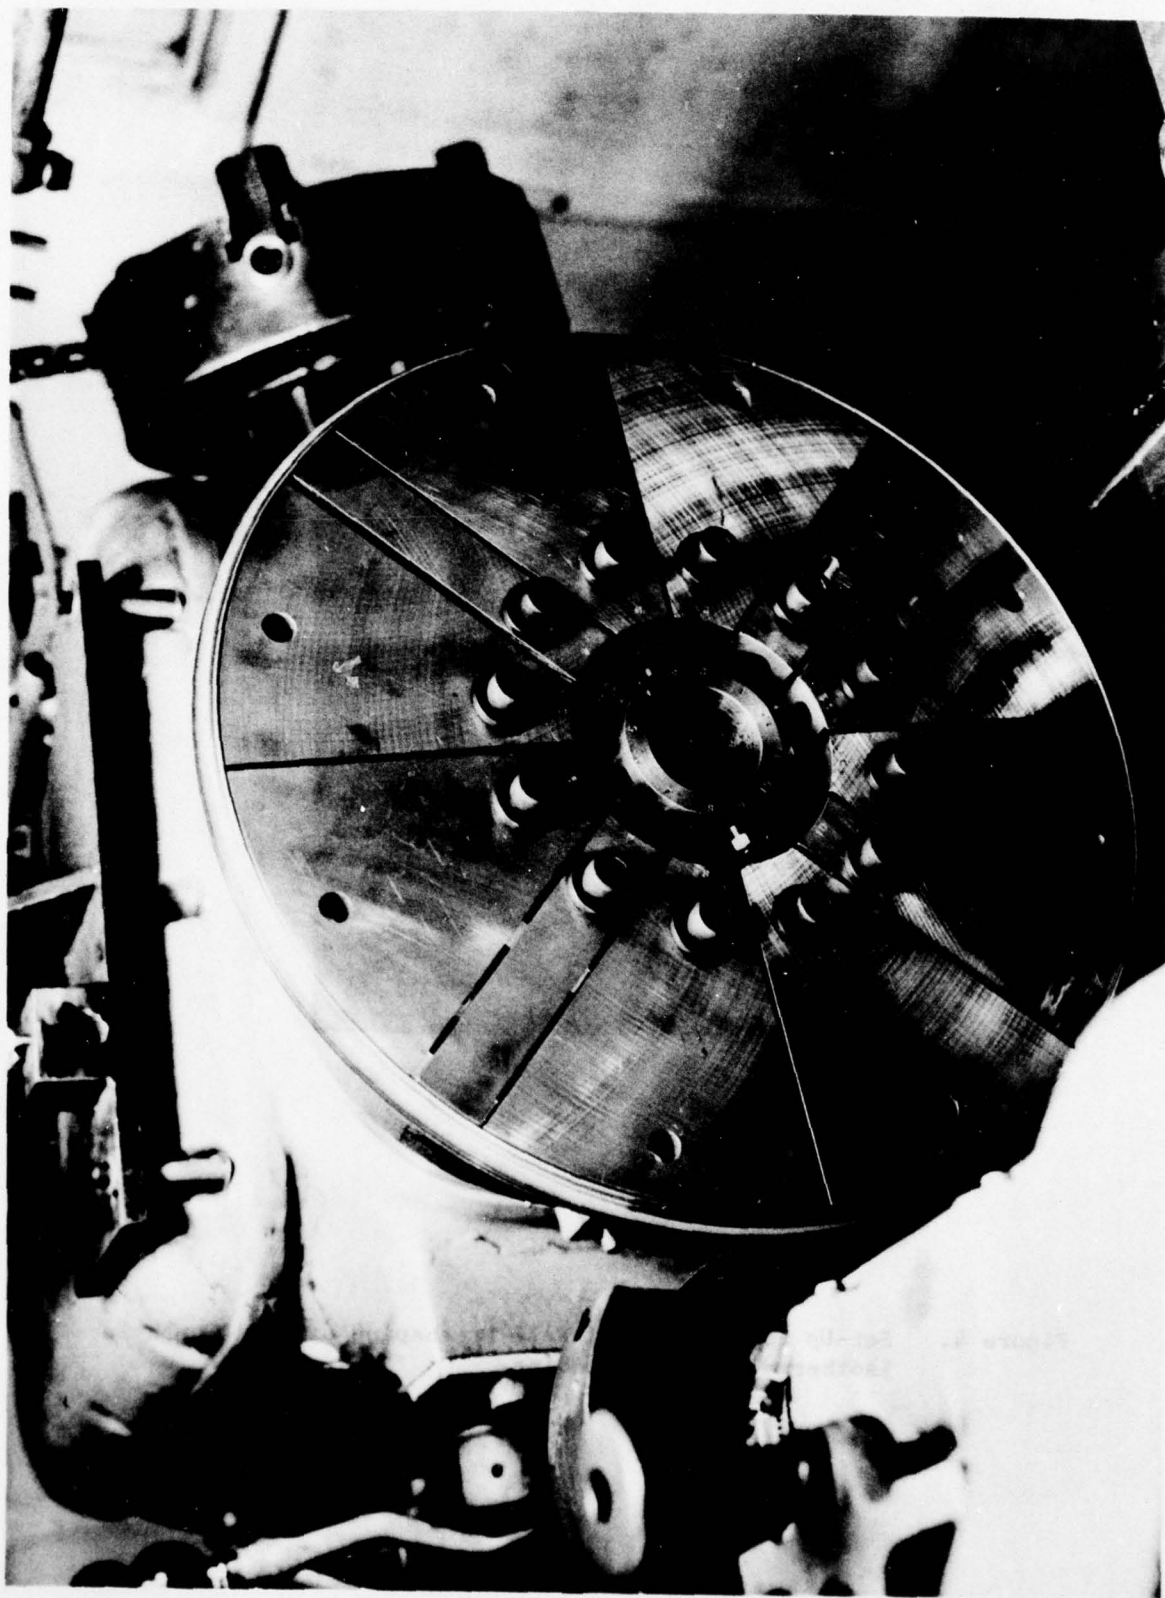
Figure 3. Set-Up For Machining Tips of Seal Teeth.

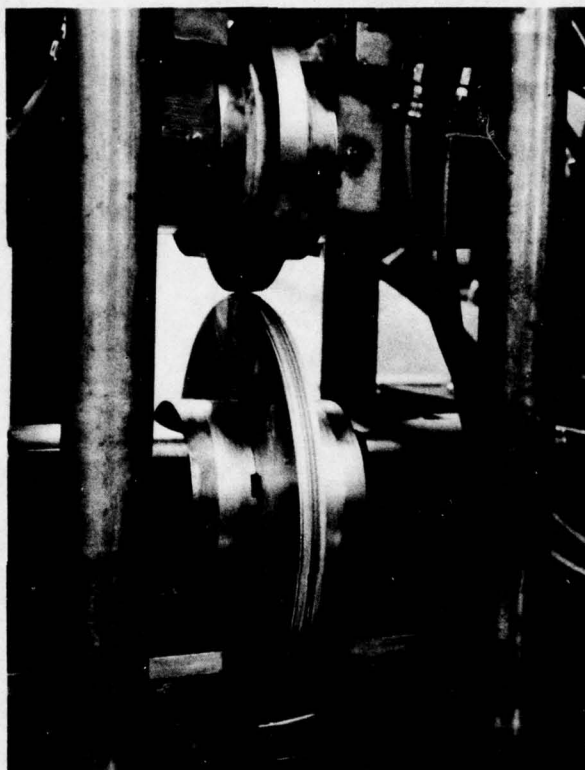
Figure 4. Set-Up For Isothermal Roll Preshaping of Seal Teeth in Isothermal Rolling Machine.

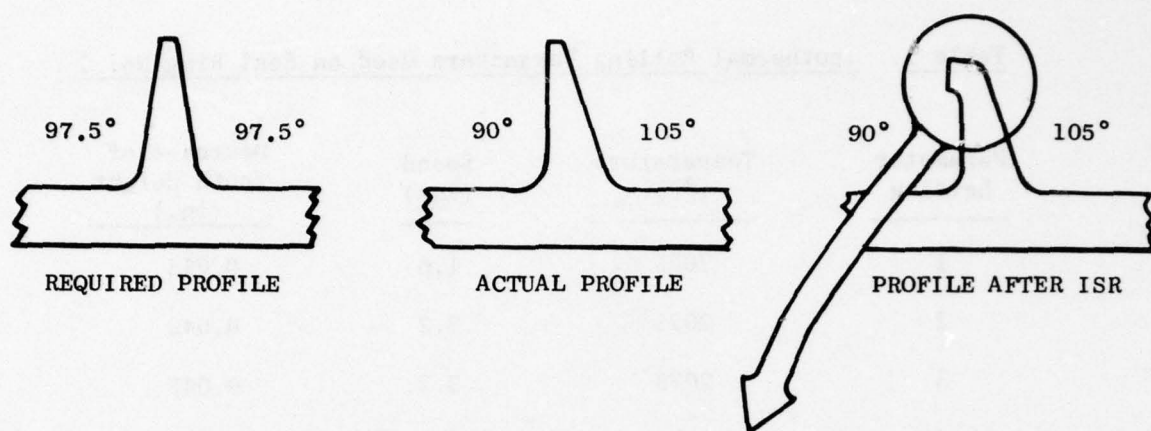
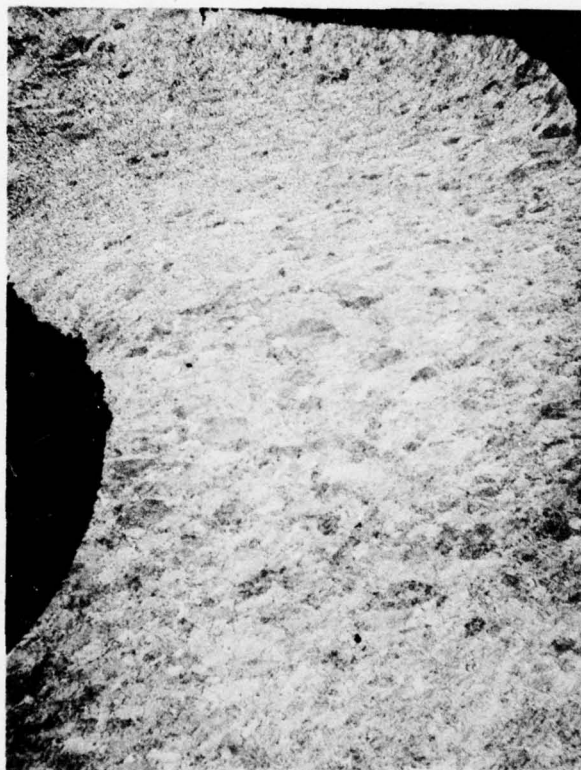
Figure 5. Non-Symmetrical Profiles of René 95 Seal Teeth and Microstructure After Isothermal Rolling at 2025°F.

Evaluation of the microstructures by Solar and General Electric indicated that a rolling temperature of 2025°F was near optimum as illustrated in Figure 5. Although some solutioning of the carbides could be tolerated, at the higher rolling temperature of 2075°F it was too extensive and incipient melting was detected at 500X. At 1950°F, evidence of cold worked grains and shear tears were observed. The microstructure of the center tooth also indicated that it had reached a higher temperature than the outside teeth. The probable cause of the cooler outer teeth was radiation losses. This was not a limiting concern and all three teeth were within a $\pm 25^\circ\text{F}$ acceptable tolerance.

Examination of the first isothermally rolled seal teeth ring revealed a nonsymmetrical tooth profile in the originally machined condition. Although the upset profiles of all three teeth, in each set, were comparable, they were judged questionable for subsequent CSDB repair because the rounded edge could leave unbonded areas at the end of the joint after CSDB. This situation and its impact on the rolled teeth are also depicted in Figure 5. The four remaining rings were returned to General Electric for reprofiling before isothermal rolling as shown in Figure 6. The black areas indicate the material that was removed to obtain the proper contour. The reprofiling was done on a vertical turret lathe with the same grinding equipment which is used for finish grinding production CRS seal teeth. It should be realized that the

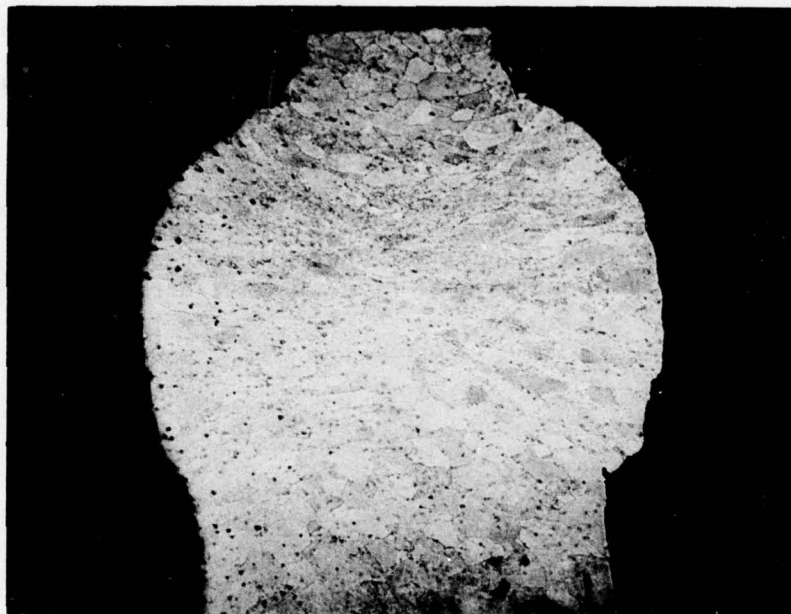
Figure 7. René 95 Seal Teeth Profile After Isothermal Rolling Symmetrical Seal Teeth at 2025°F.

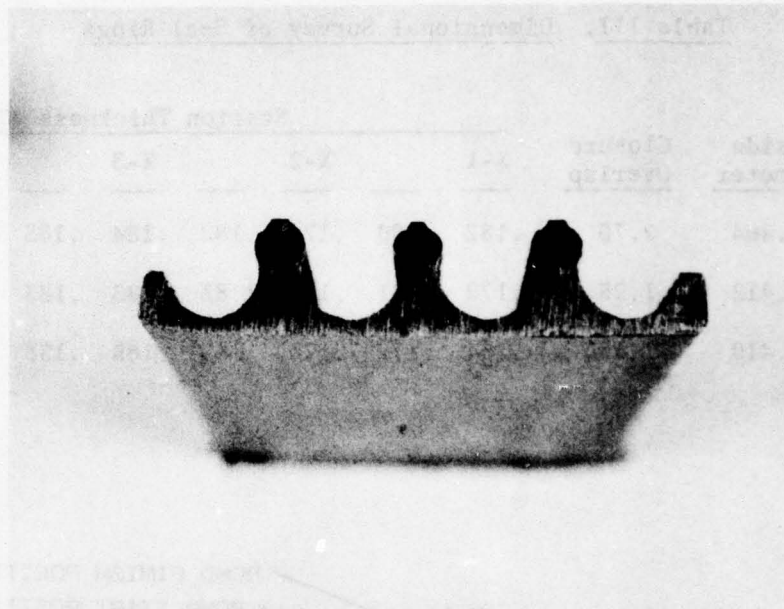
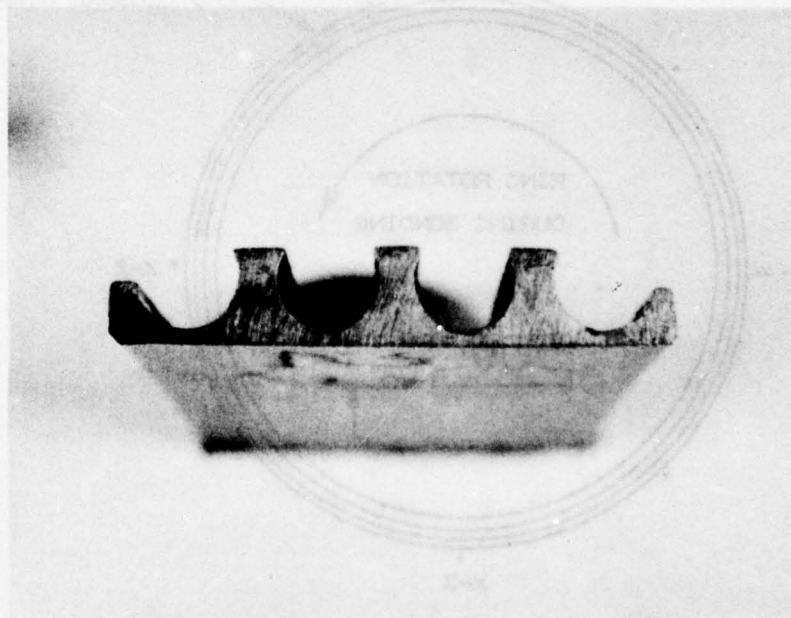
Figure 8. Seal Teeth Profiles After Isothermal Roll Preshaping and Grinding to Center of Upset Area.

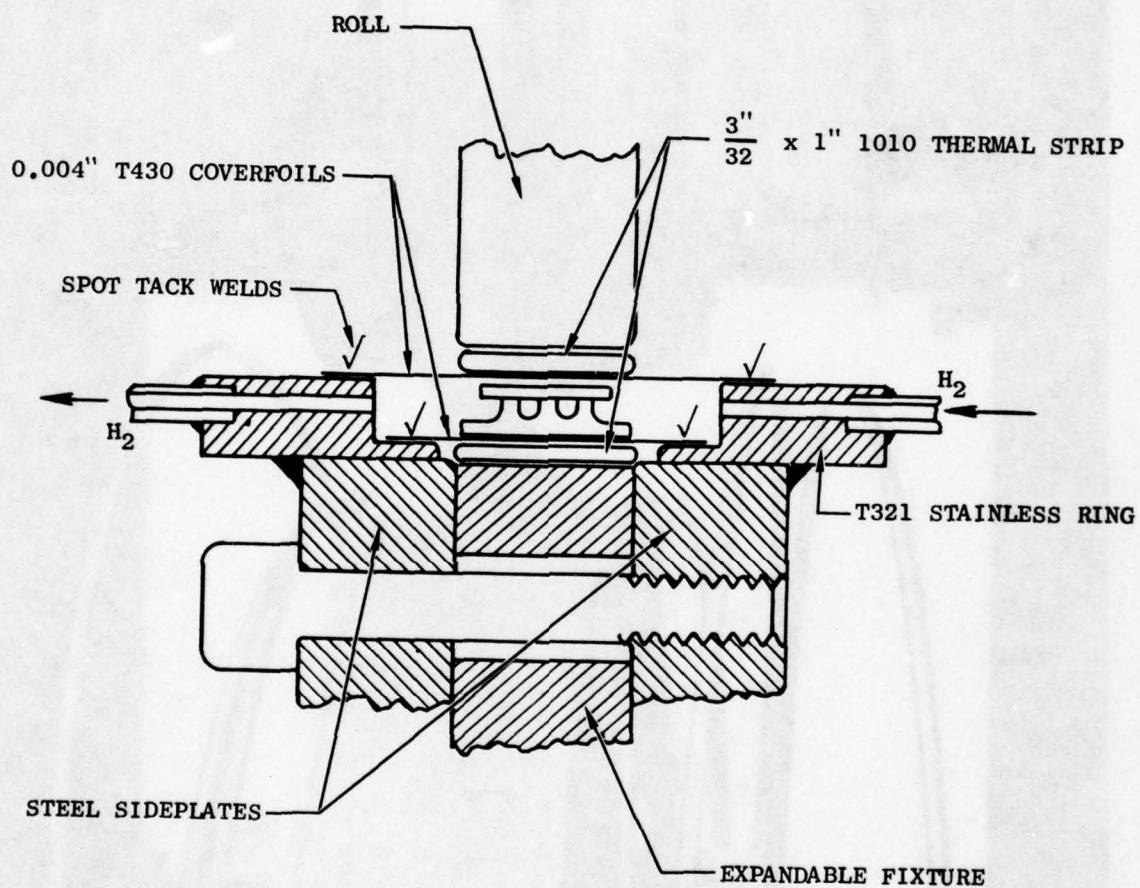
Figure 9. Cross-Section of Bonding Lay-Up For CSDB of Seal Teeth Rings.

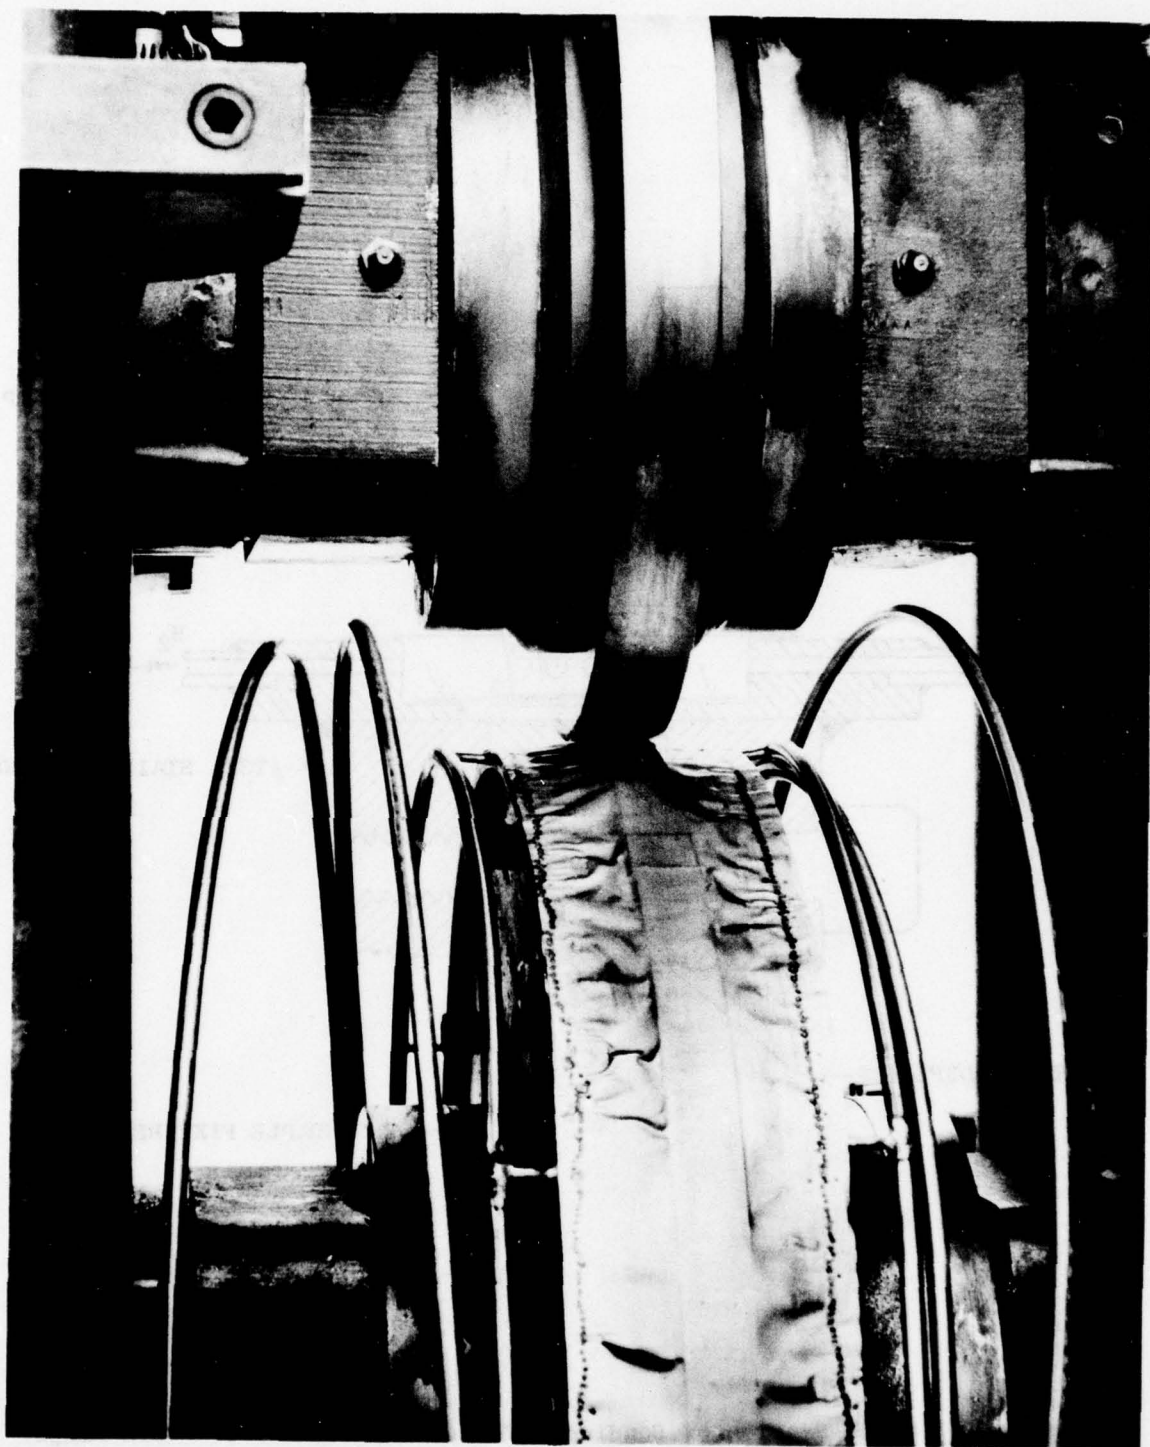
Figure 10. Set-Up For CSDB of Seal Teeth Rings in Isothermal Rolling Machine.

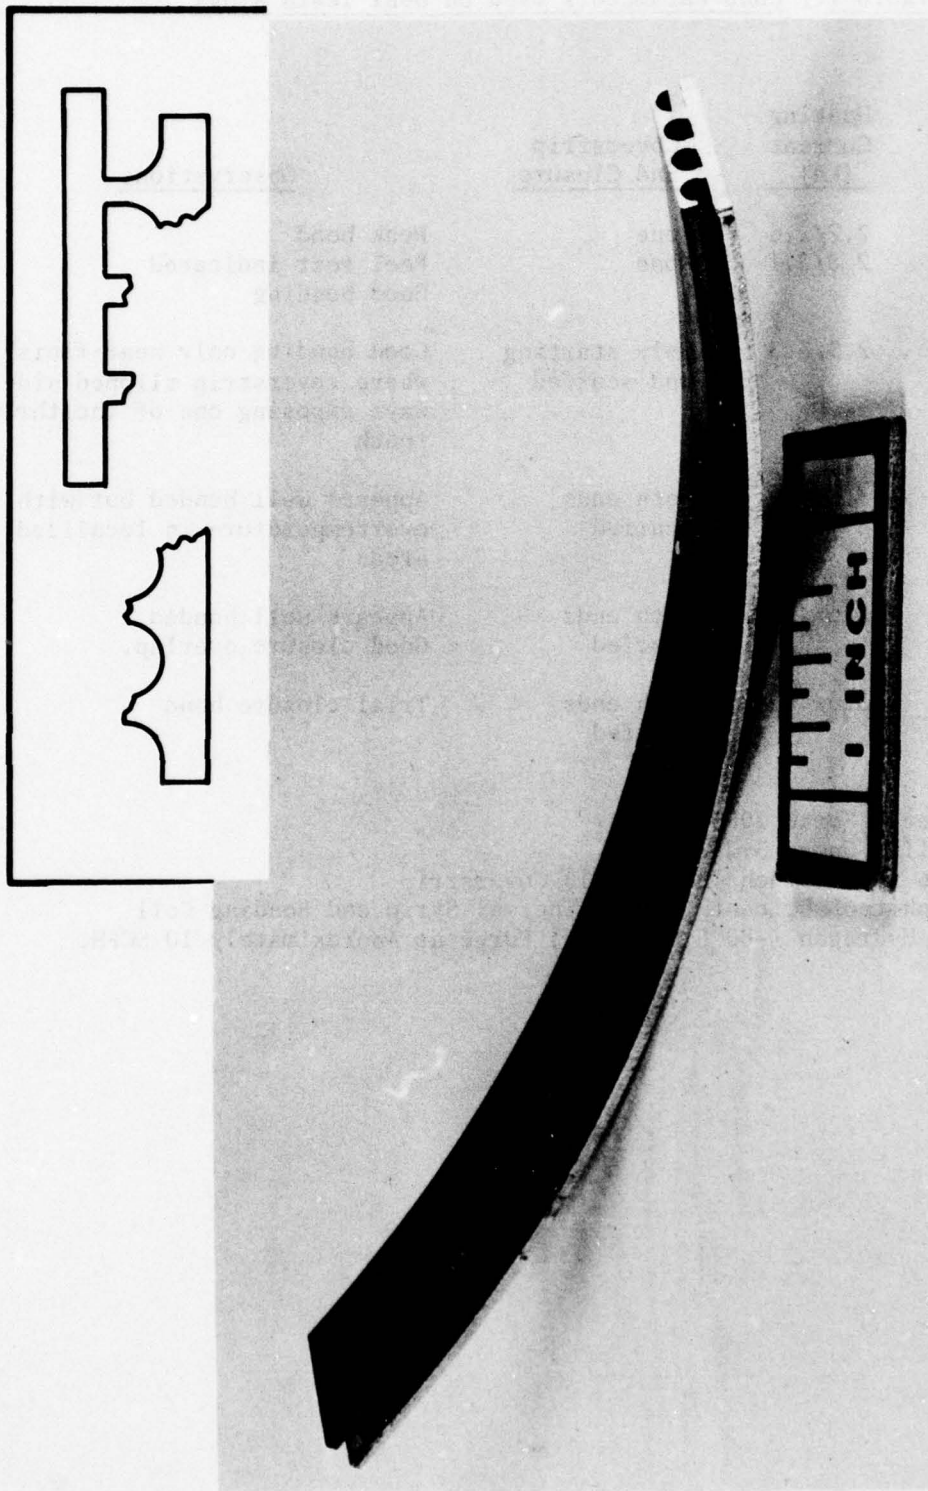
Figure 11. Section of CSDB'ed Seal Teeth Ring and Peel Tests Initially Used to Evaluate Bond Quality.

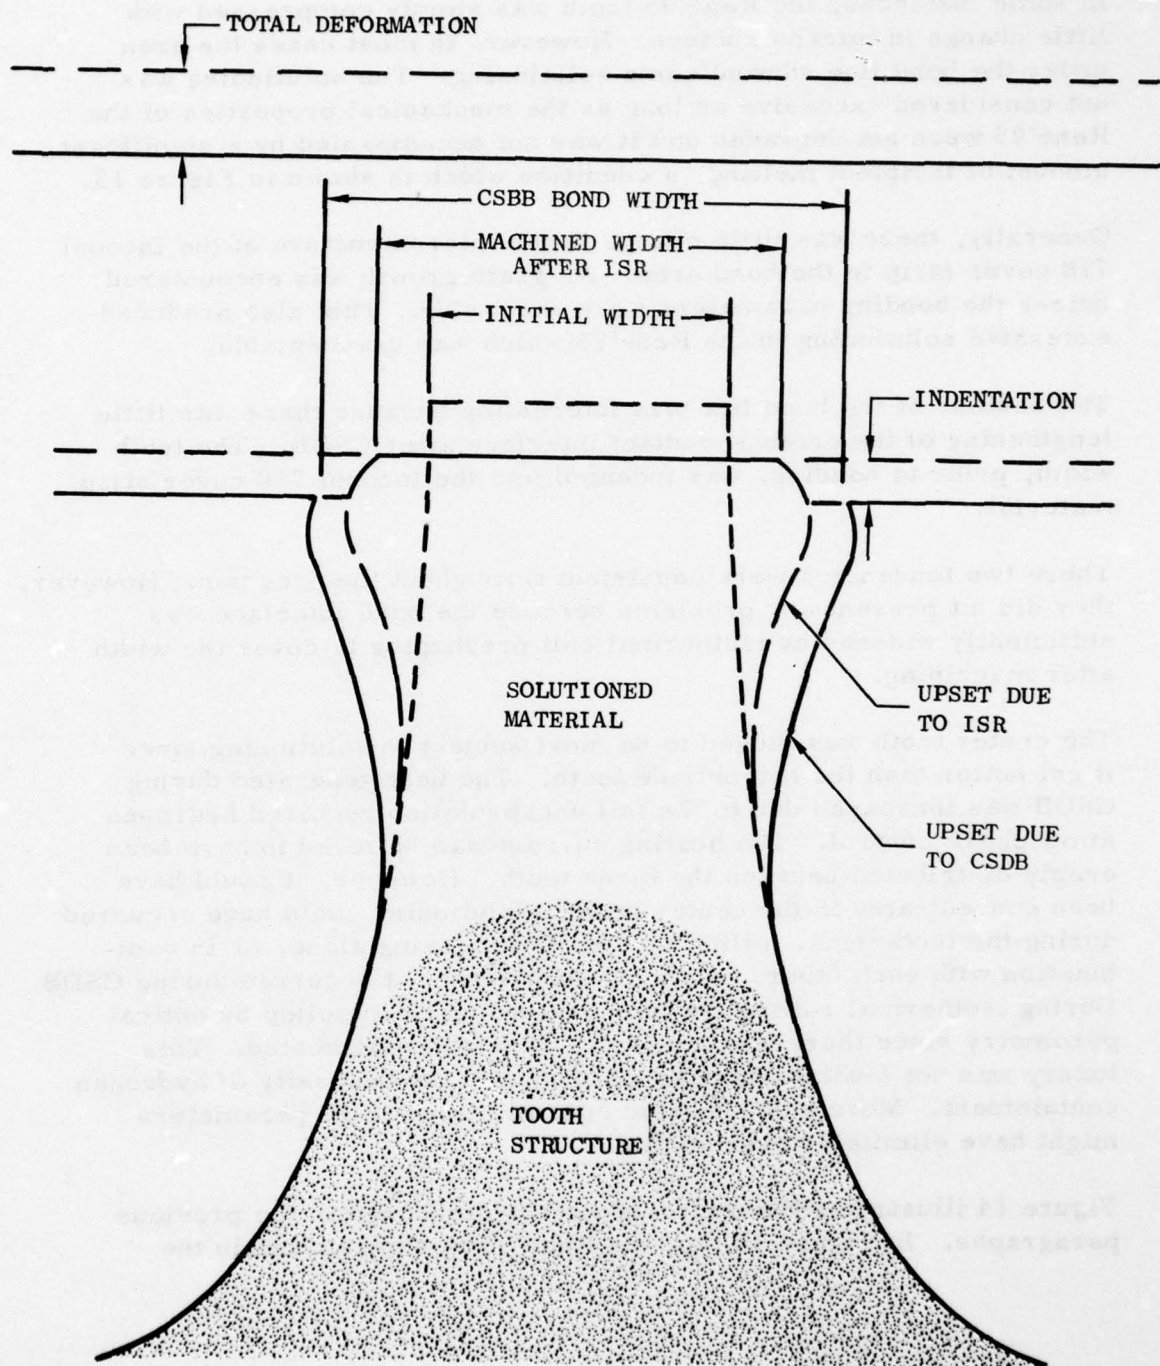
Figure 12. Pictorial Representation of Isothermal Roll Preshaping and CSDB Processing on Seal Teeth.

tooth obtained during the parameter study is illustrated in Figure 12. In some instances, the Rene'95 tooth was simply compressed with little change in microstructure. However, in most cases the area under the bond line showed some solutioning. The solutioning was not considered excessive as long as the mechanical properties of the Rene'95 were not degraded and it was not accompanied by a significant amount of incipient melting, a condition which is shown in Figure 13.

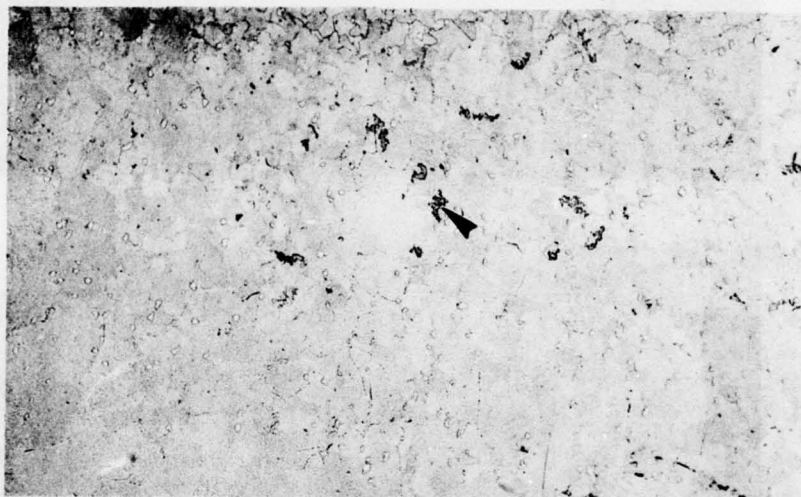
Figure 13. Incipient Melting Found in Rene 95 Seal Teeth.

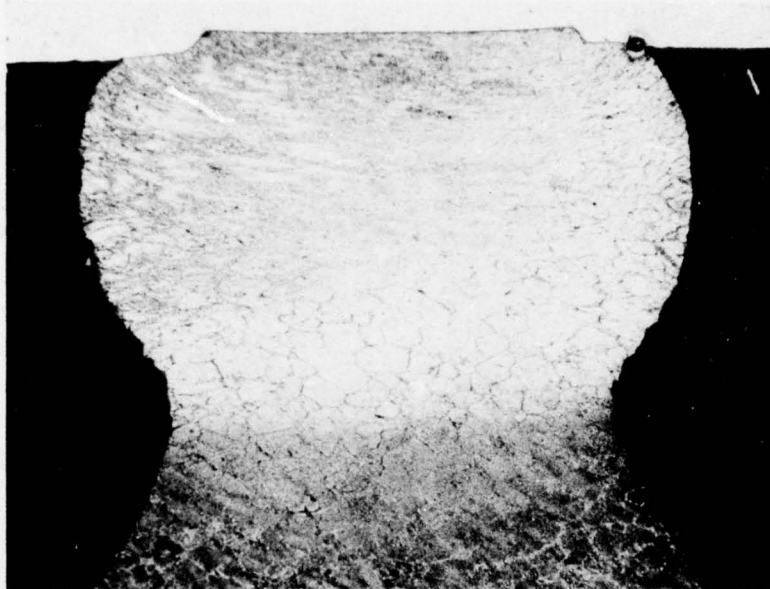
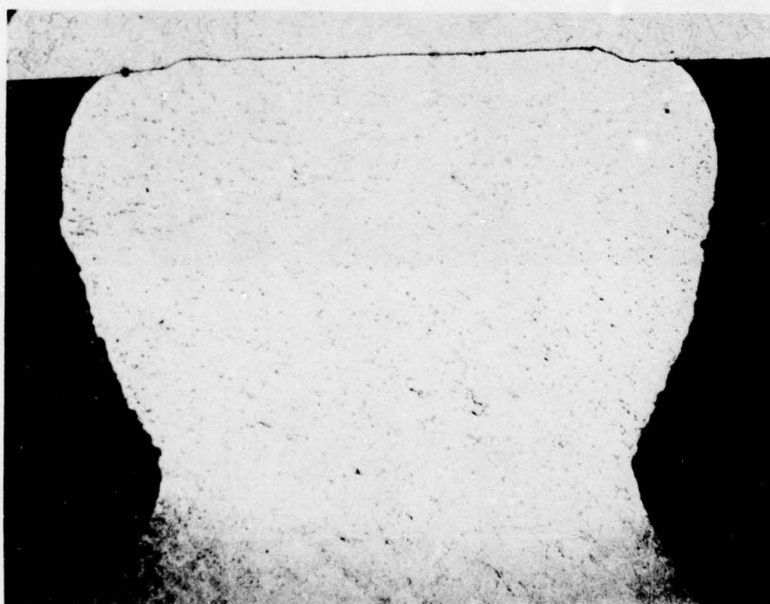
Figure 14. Sections Through CSDB Seal Teeth.

Figure 14 illustrates the microstructures discussed in the previous paragraphs. In Figure 14 top, the Rene'95 is compressed in the

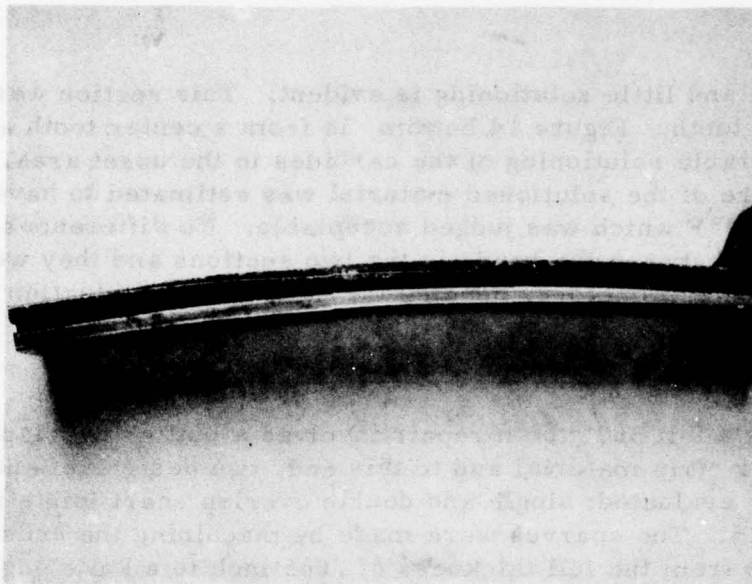
Figure 15. Single and Double Overlap End Closures.

Bottom: Single Overlap Scarf Joint

The trial closure from ring #2 had the double overlap joint while that of ring #4 had the single overlap as previously shown in Figure 15. Visually, they both appeared to be bonded. However, considerable deformation resulted in the seal teeth under the single overlap joint.

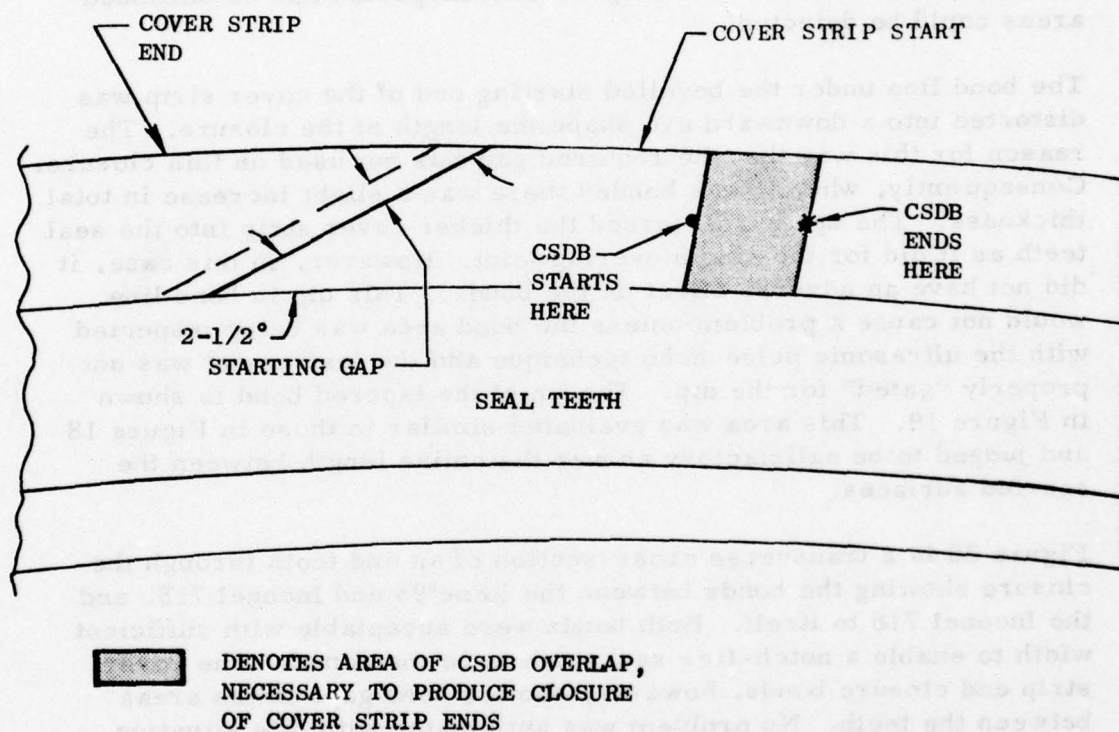
Figure 16. Pictorial Representation of CSDB End Closure Processing.

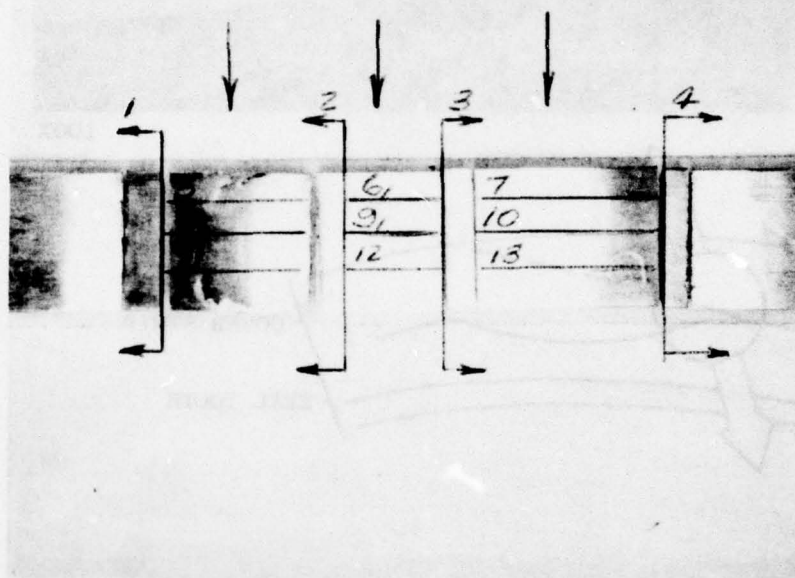
Figure 17. Top Surface of Trial End Closure.

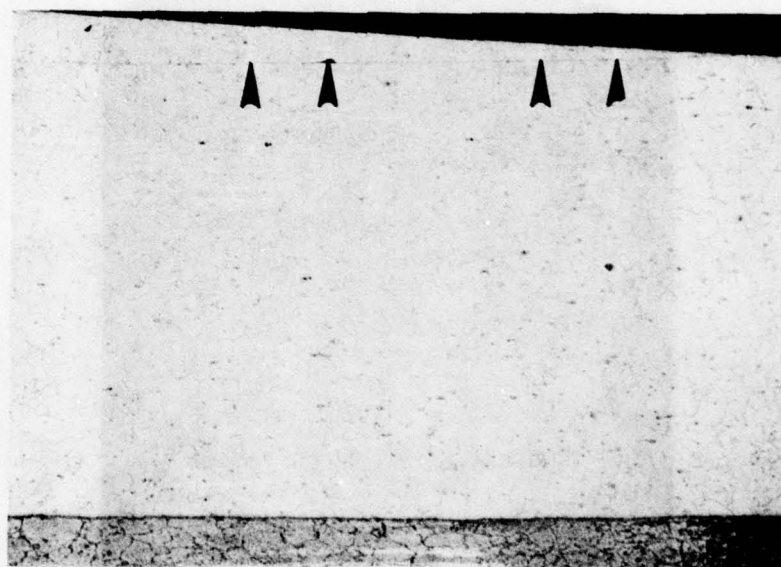
NOTE: ARROWS INDICATE BOND

Figure 19. Trial End Closure Longitudinal Section, Location 5.

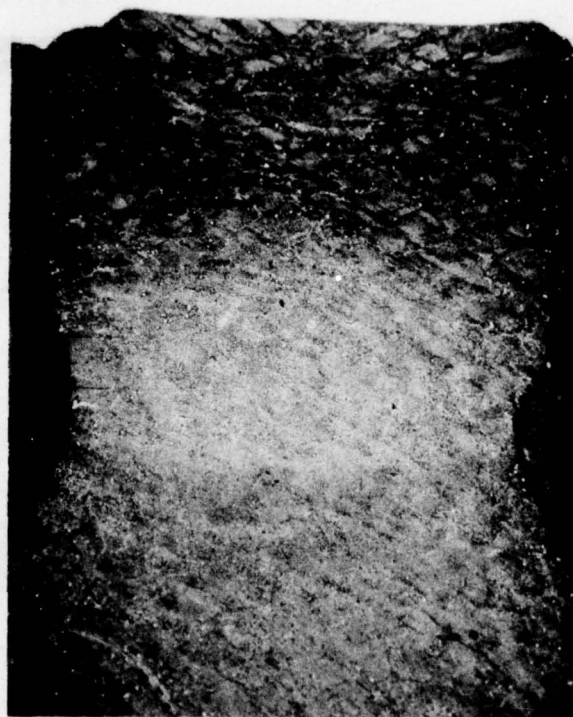
Figure 20. Trial End Closure Transverse Section, Location 2.

Figure 20 is a transverse cross-section of an end tooth through the closure showing the bonds between the Rene'95 and Inconel 718, and the Inconel 718 to itself. Both bonds were acceptable with sufficient width to enable a notch-free seal tooth to be machined. The cover strip end closure bonds, however, showed bond gaps in the areas between the teeth. No problem was anticipated with this situation because these areas are machined away. The lack of bonding in the areas between the teeth is probably the result of insufficient bond pressure and actually enhances the bonding in the desired location above the teeth. It is also another reason that both interfaces could be bonded at the same time without changing parameters.

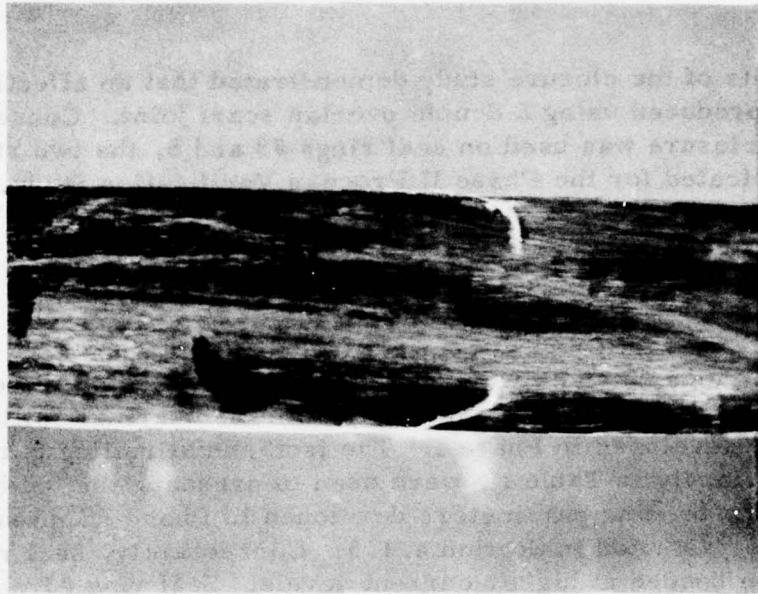
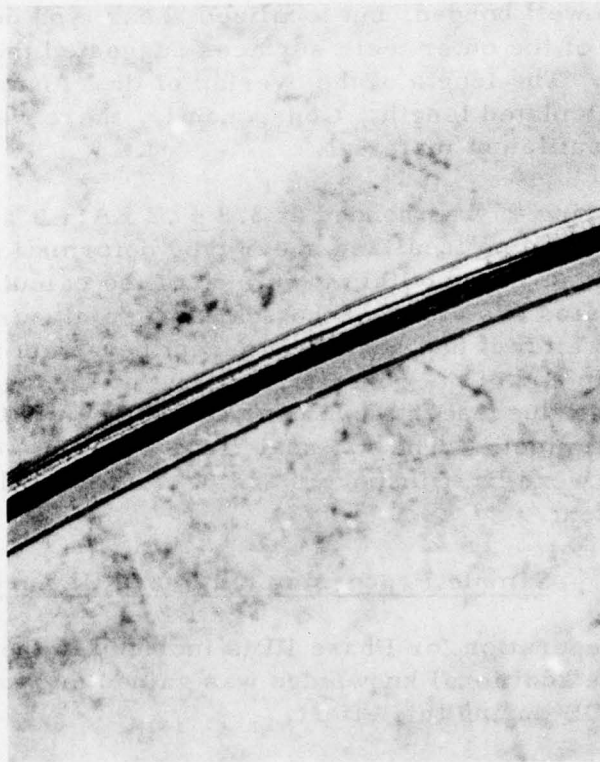
Figure 21. End Closure of Seal Ring #5.

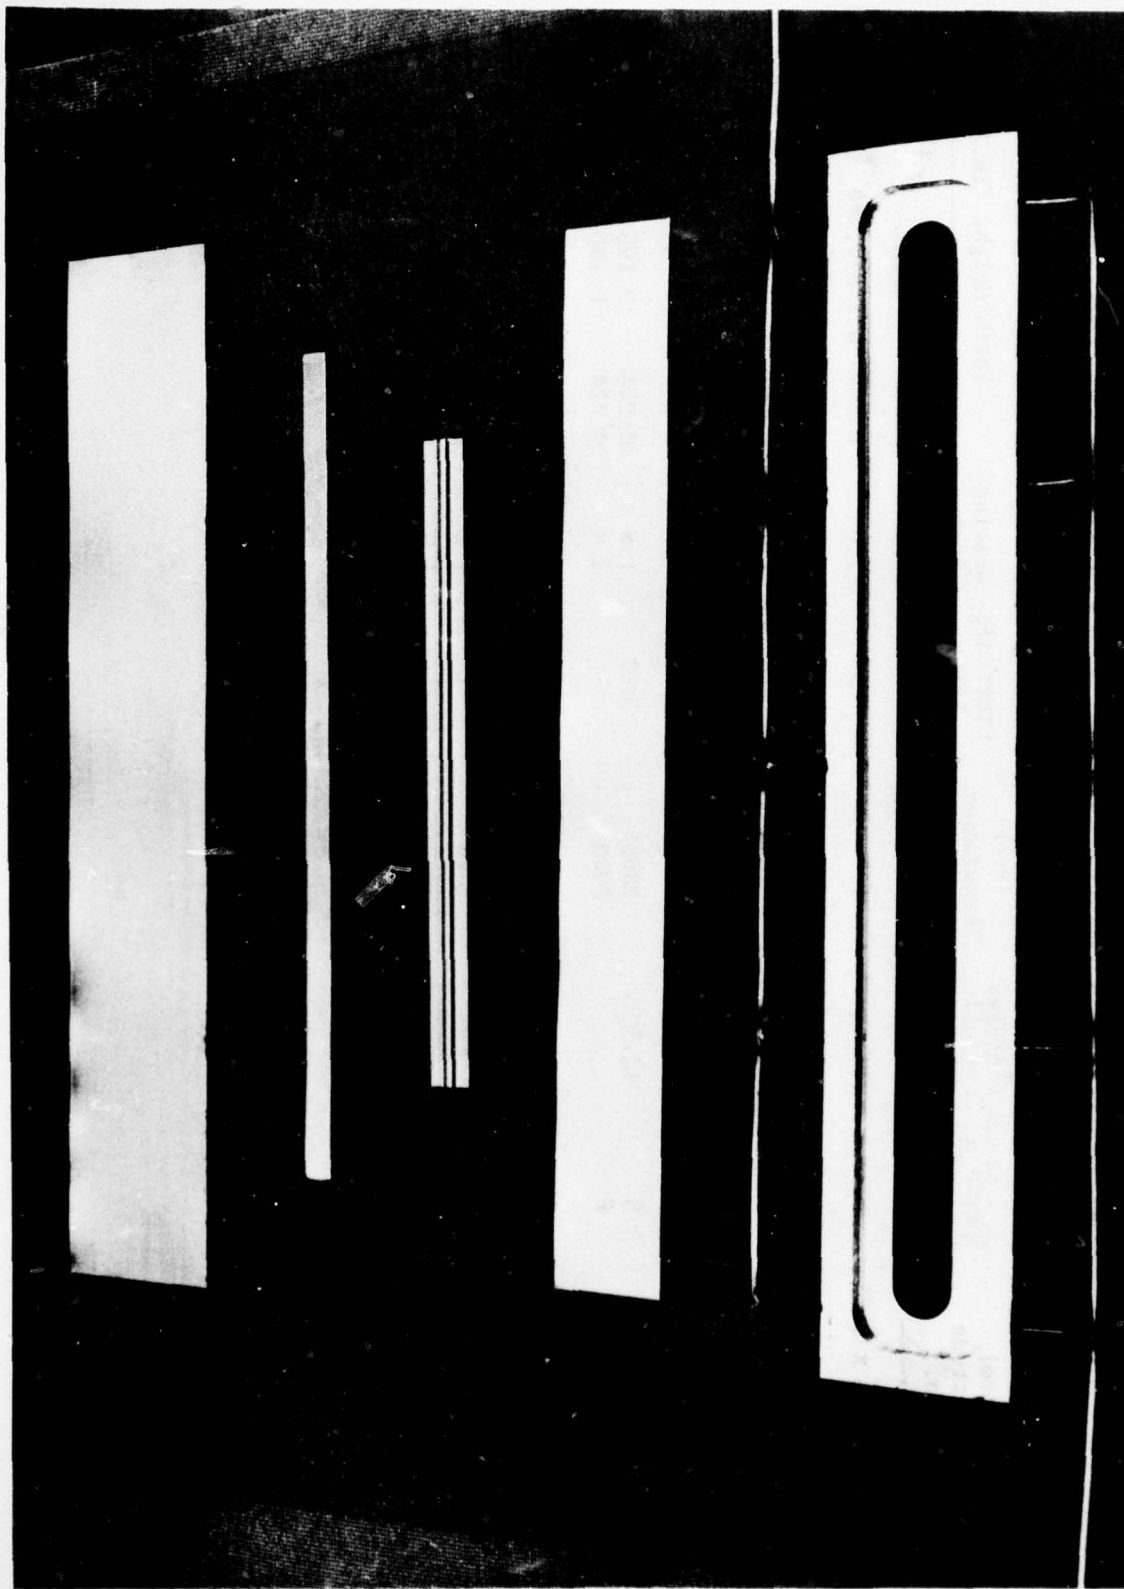
Figure 23. Bonding Fixture and Component Parts For CSDB of Flat Seal Teeth Bars.

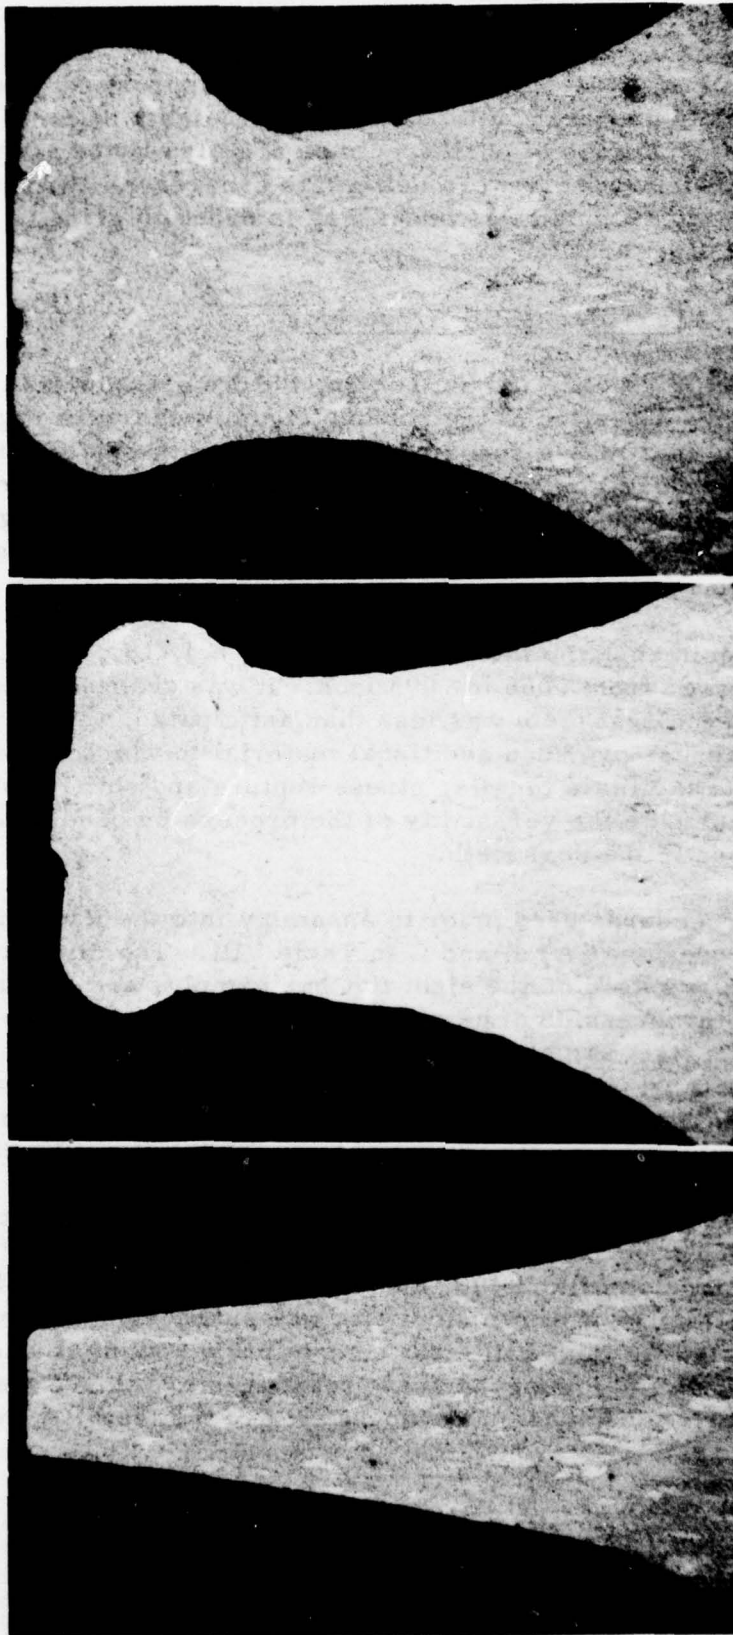
Figure 24. Contours and Microstructures of Flat Seal Teeth Bars After Isothermal Rolling.

Left: Prior to Rolling

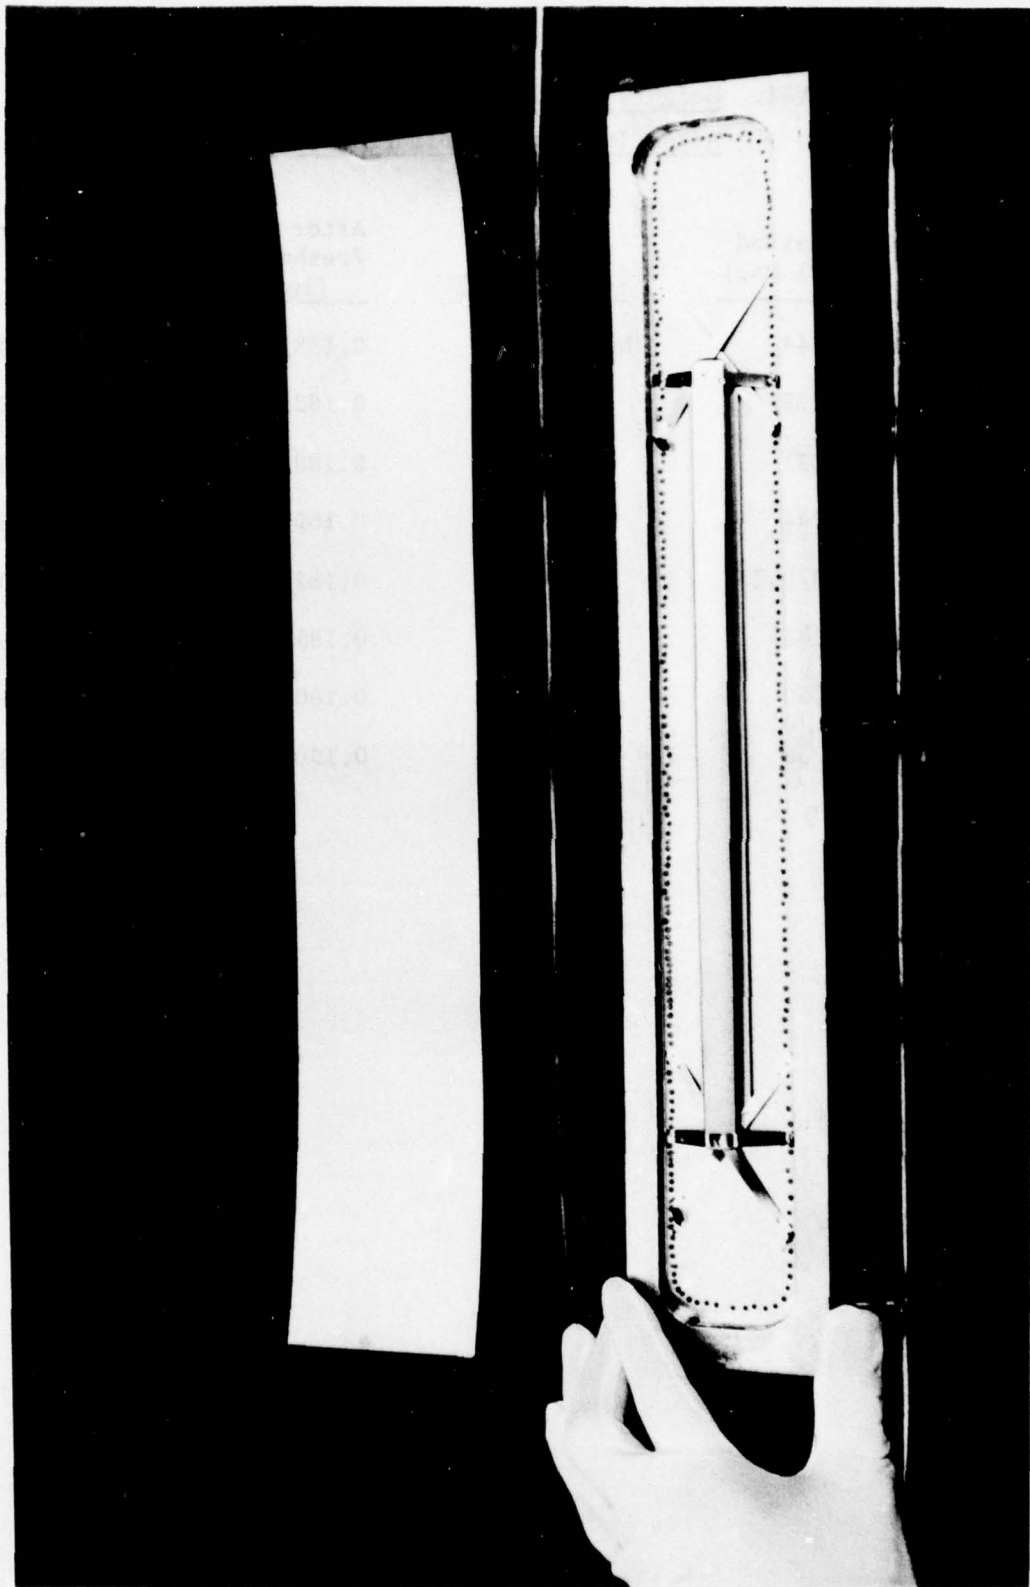
Figure 25. Assembled Bonding Lay-Up For Flat Seal Teeth Bars.
